Aquatic insect responses to stream restoration. How do we define success?

Dave Penrose and Lara Rozelle, Biologists, NCSU Water Quality Group, Campus Box 7637, Raleigh, NC 27695-7637

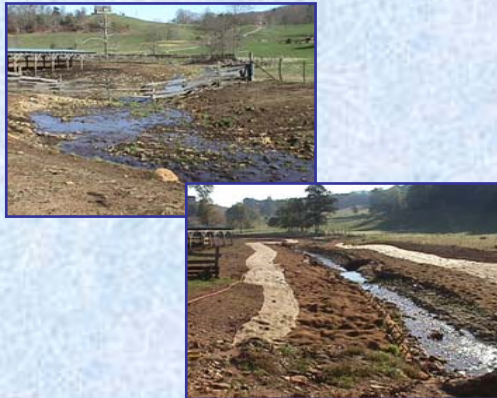
Figure 1. Stream prior to and during restoration

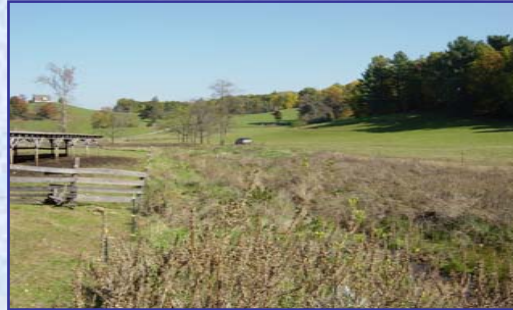
Figure 2. Same stream two years following restoration.
